Manhole Inspection Summary

Manhole # S45UU_021MH

Insp Date: **2/8/07 9:43 AM**

Location Address: **2746 TIVOLY AVE**

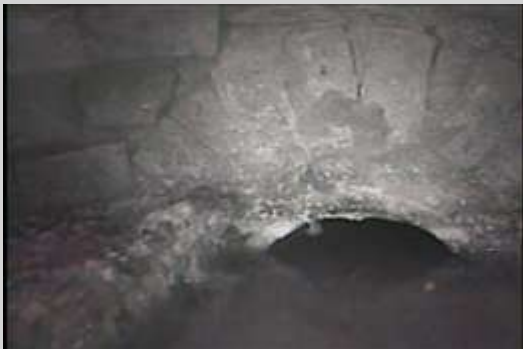
8 in. Circular Gravity Sewer Pipe In @ 3 O'Clock

Pipe Material: **Clay** ☐ Pipe Lined

Infiltration: **None** Pipe Seal Cond: **Unknown**
